**SURFACE PREPARATION
AND COATING**

Drying and Coating Concrete at the National Aquarium

Case Study: Drying and Coating Concrete at the National Aquarium

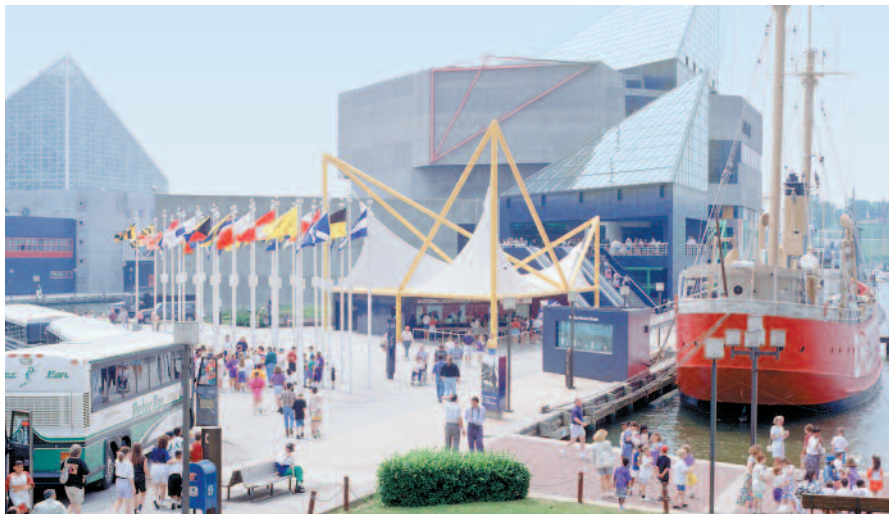
At the National Aquarium in Baltimore, Polygon helped the contractor dry out wet concrete quickly, improving adhesion and keeping the project on schedule and on budget.

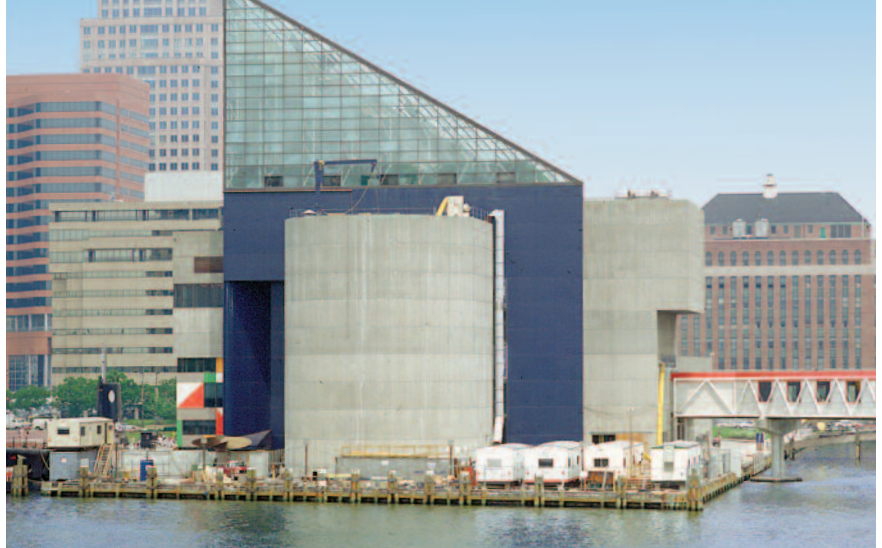
Handling a difficult site problem — normally, large dehumidifiers would have been used to dry the 130,000 cu. ft. tank at Baltimore's National Aquarium, but limited on-site space required a more flexible solution. Polygon's versatile fleet provided combinations of lighter and smaller dehumidifiers which could be positioned in available locations.

On-site logistics were a particular challenge because the aquarium is located on a short pier, with essentially no space around the building for climate control equipment or for generators. Polygon provided a solution with equipment small enough to use on-site power and light enough to be placed on the roof. Dry air was brought through flexible hose down into the tanks. Duct runs of more than 100 ft. were common as the requirement for dry air moved throughout the building.
